# **Fabric Life – Expectations and Experience**

C.G. Tattersall  
Director, Tattersall Engineering Consultants Pty. Ltd.

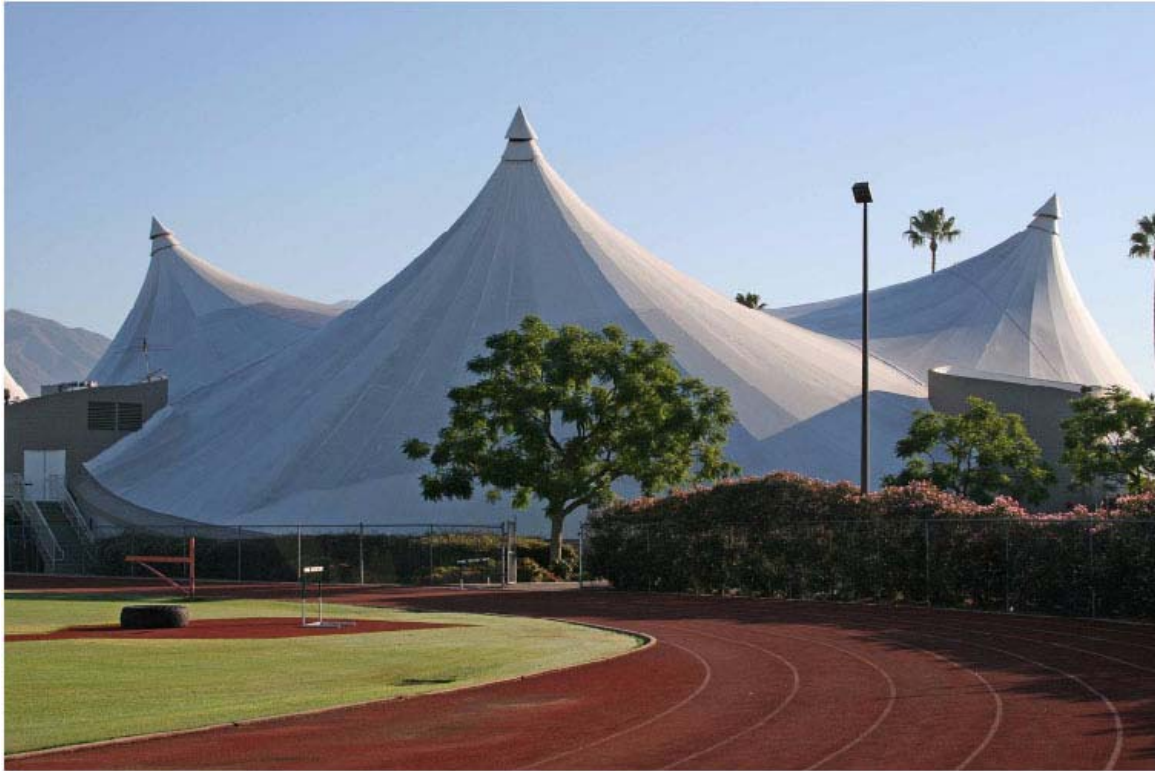
The materials considered range from early Teflon-coated fiberglass (refer figure 1 –University of La Verne Sports Science and Athletic Pavilion – built in 1972) to PVC-coated polyesters with acrylic or pvdF coatings, to knitted high density polyethylene monofilament fibre fabric, commonly known as shade cloth, (refer figure 2 – shade cloth canopies at a resort in Northern Victoria).

*Figure 1 – University of La Verne Sports Science and Athletic Pavilion (California)  
Erected 1972, photo taken 2007*

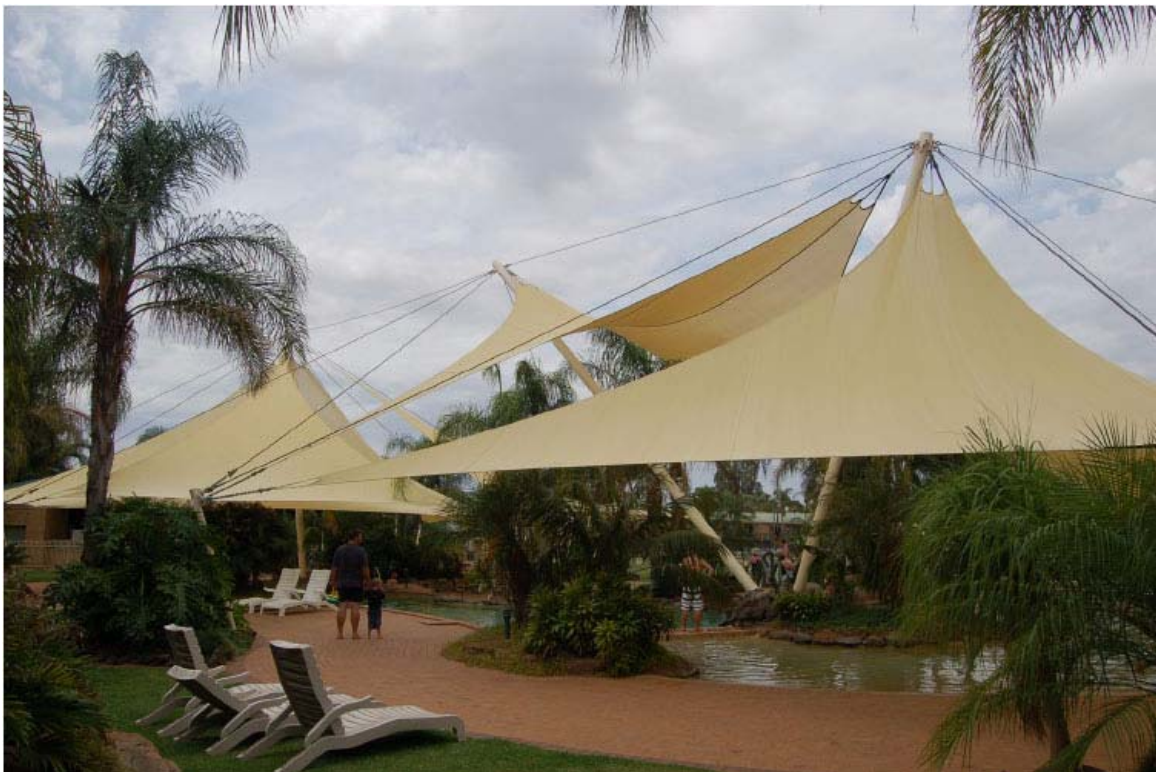
*Figure 2 – Shadecloth canopies at resort in Northern Victoria  
Installed 1997, replaced 2006*

**Case Study S1**, shadecloth structure utilising 5 membranes totaling about 1200 square metres in area, over a resort swimming pool in Northern Victoria. (refer figure 2 earlier in this paper). This was first erected in 1997, as a replacement for membranes of different materials, construction and design, which had suffered structural failure a short time after installation. An elegant design, utilising a number of layered profiles overlaying each other and generally inclined to the north, the structure allows sunlight penetration to the pool areas during winter and cooler months whilst providing several layers of shadecloth for increased shade density in summer.

By late 2006 the membranes were suffering deterioration due to a combination of stitching deterioration under UV, physical damage due to vandalism and bird strikes, and seams being highly stressed by unauthorised access by a number of people climbing on the panels at one time.

They were replaced with new membranes utilising improved stitching with a guaranteed 15 year UV resistance and hopefully will provide many years of reliable service.

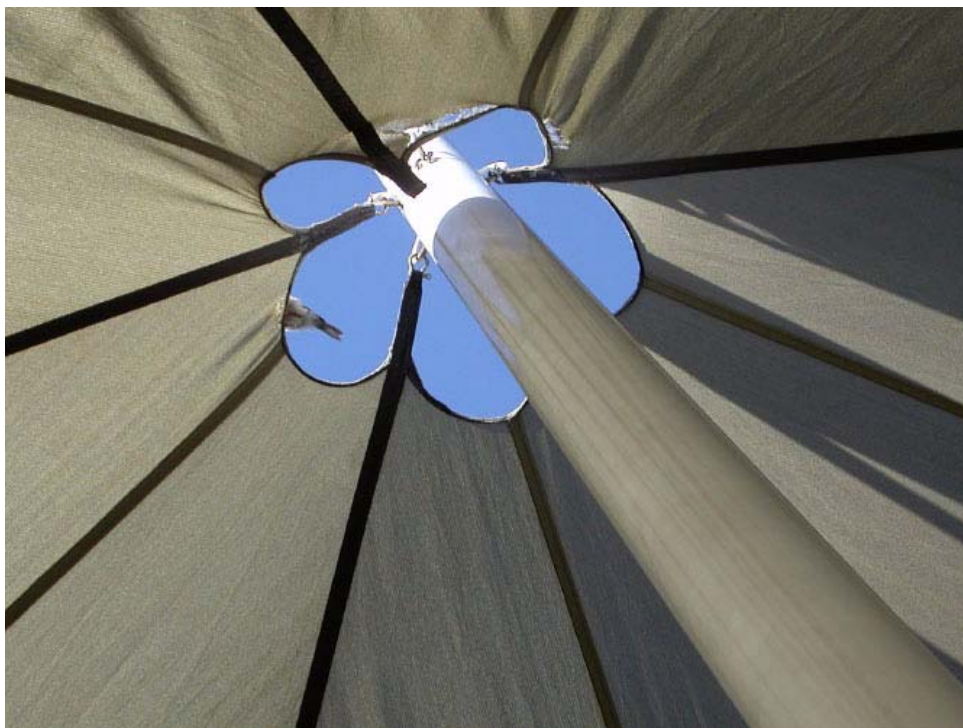
**Case Study S2**, a shadecloth conic at a primary school in the northern suburbs of Melbourne, erected in 2000. This suffered some deterioration of the shadecloth around webbings, possibly due to UV deterioration, but also possibly due to birds pecking at the fabric, seeking insects or spiders at the peak (refer figure 3). The structure was taken down in 2006 and the damage repaired, and is still in service.

*Figure 3 – Shadecloth structure at School, installed 2000, repaired 2006*

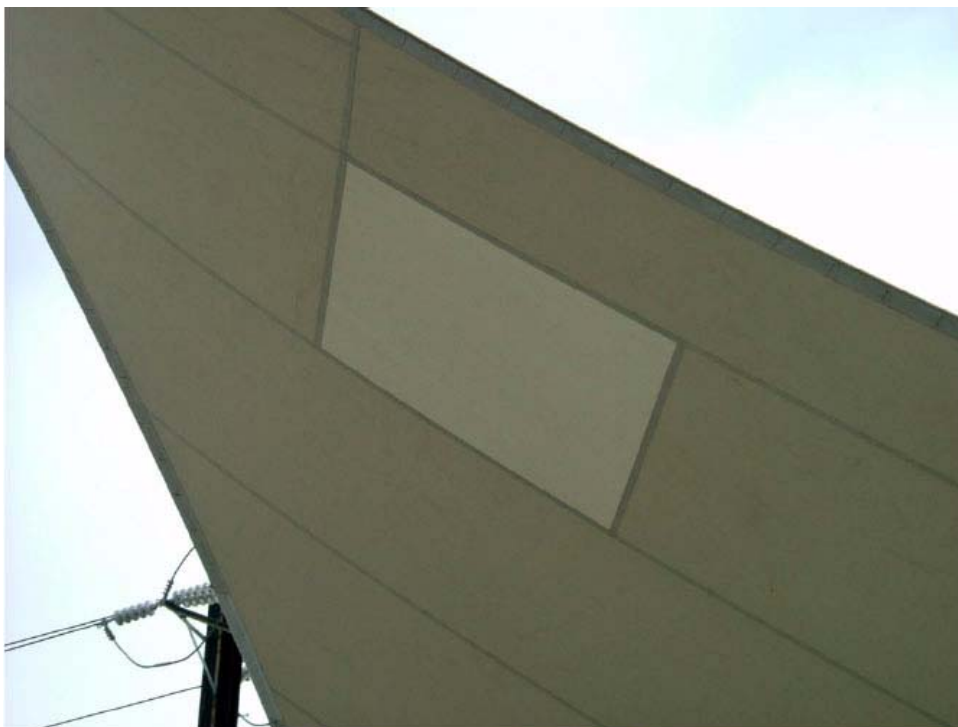
What is more obvious however, is the visual appearance, and there was a quite distinct difference in gloss, colour and translucency between the original fabric and the replacement fabric, which was of a similar grade although with a weldable pvdf coating instead of an acrylic coating (refer figure 4)

*Figure 4 – repair of tear in PVC-coated Polyester membrane, installed 1996, repaired 2006*

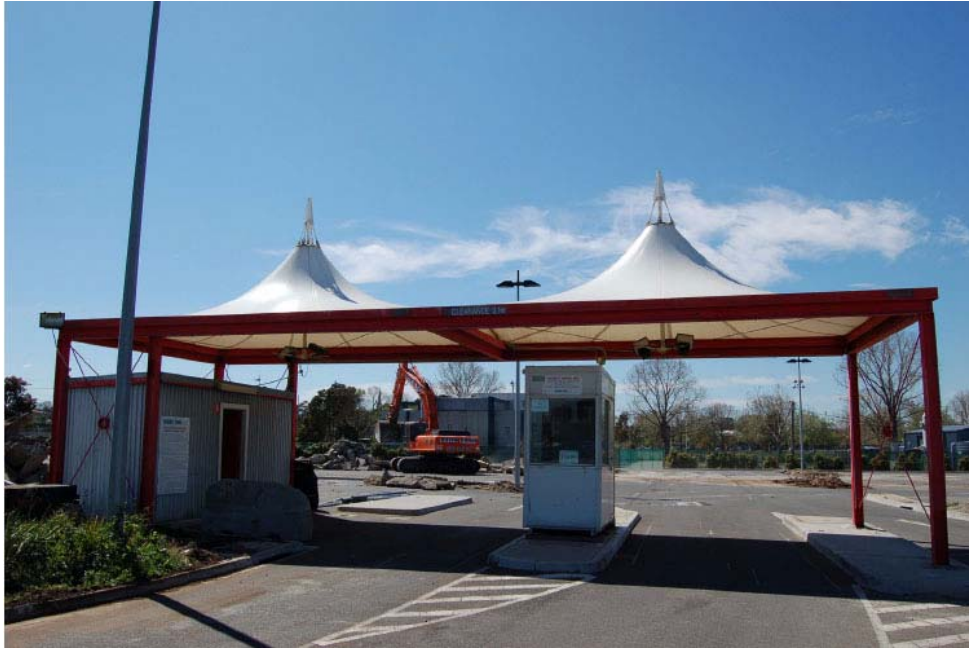
**Case Study P2.** This was a small twin conic erected in 1990 and was to the author's knowledge the first application of a PVDF/PVC coated polyester fabric in Australia. The structure was designed by the author and the fabric selected as a trial since the small scale minimized economic consequences if the fabric performed poorly. It has now been in place for nearly 17 years and is still performing well, having been cleaned and relocated on a few occasions (refer figure 5).

*Figure 5 – twin conic in pvc-coated polyester with PVDF, erected 1990, photo October 2007*

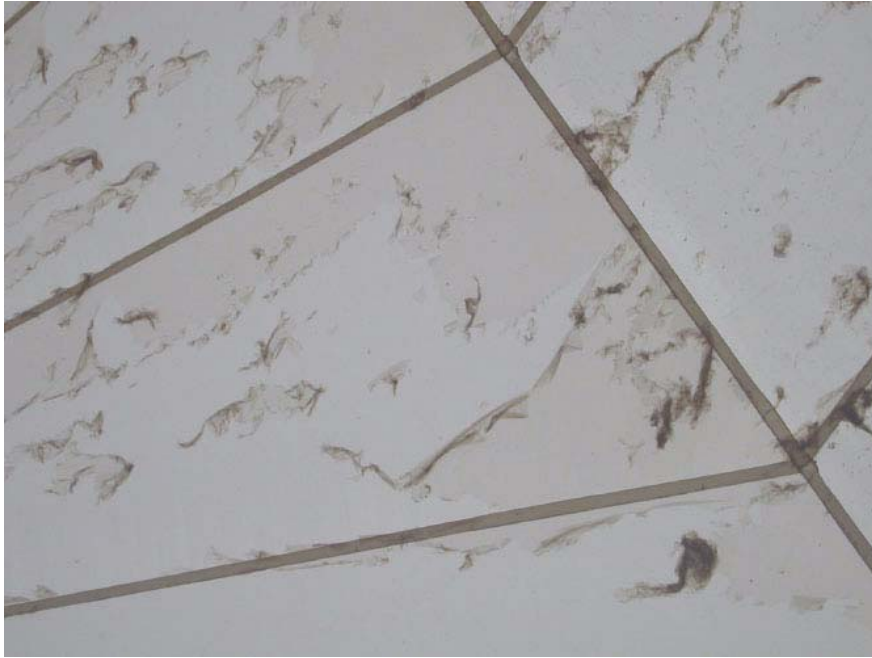
**Case Study P3.** PVC-coated polyester structure with PVDF surface, erected in 2000, suffered a severe failure of the PDVF laminate in late 2003, not affecting structural integrity, fire resistance or water-tightness, but causing a reduction in gloss of the surface and an unsightly appearance as dust and soil builds up under the delaminating coating. This requires regular cleaning to remove the delaminated coating, when hopefully a uniform appearance will be restored. (refer figure 6)

*Figure 6 – delamination of surface coating on pvdf/pvc-coated polyester, installed 2000, coating issue arose at end of 2003*

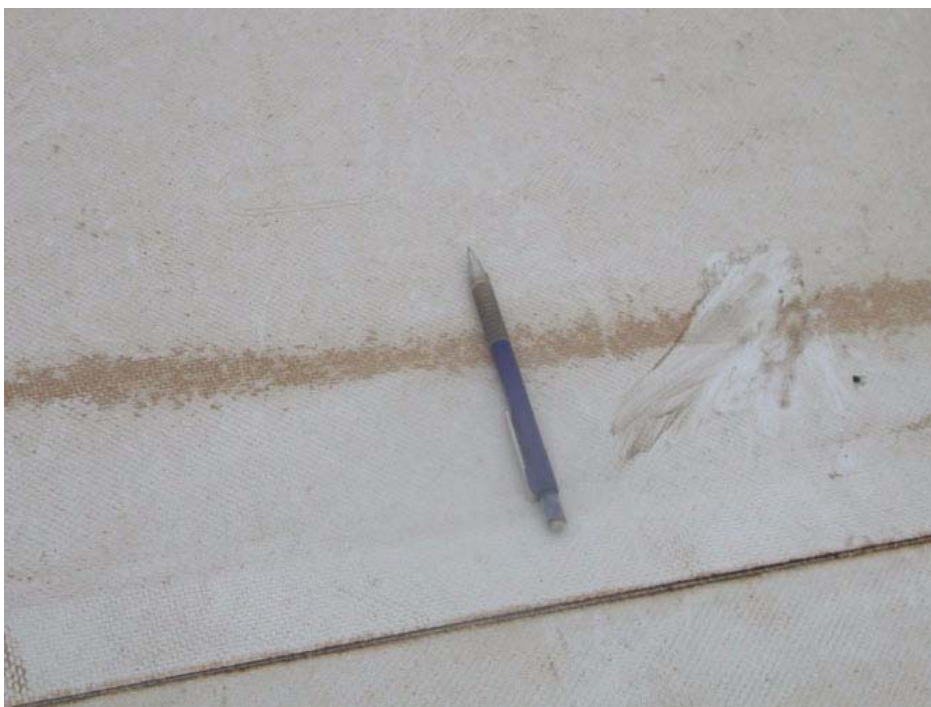
**Case Study P4,** A barrel vault canopy of erected in December 2001, showing considerable soiling in defined lines, but not at valleys, prior to the first clean in June 2004 (refer figure 7). The fabric was installed taut at pretension levels of 1.5x1.5 kN/m and has no wrinkles or defects, but soiling was apparent at lines which may have been where the fabric was folded during manufacture, transport and installation.. The soiling cleaned off and a uniform glossy surface was restored with normal cleaning following recommended procedures.

*Figure 7 – soiling in lines on surface of weldable PVDF/PVC-coated polyester*

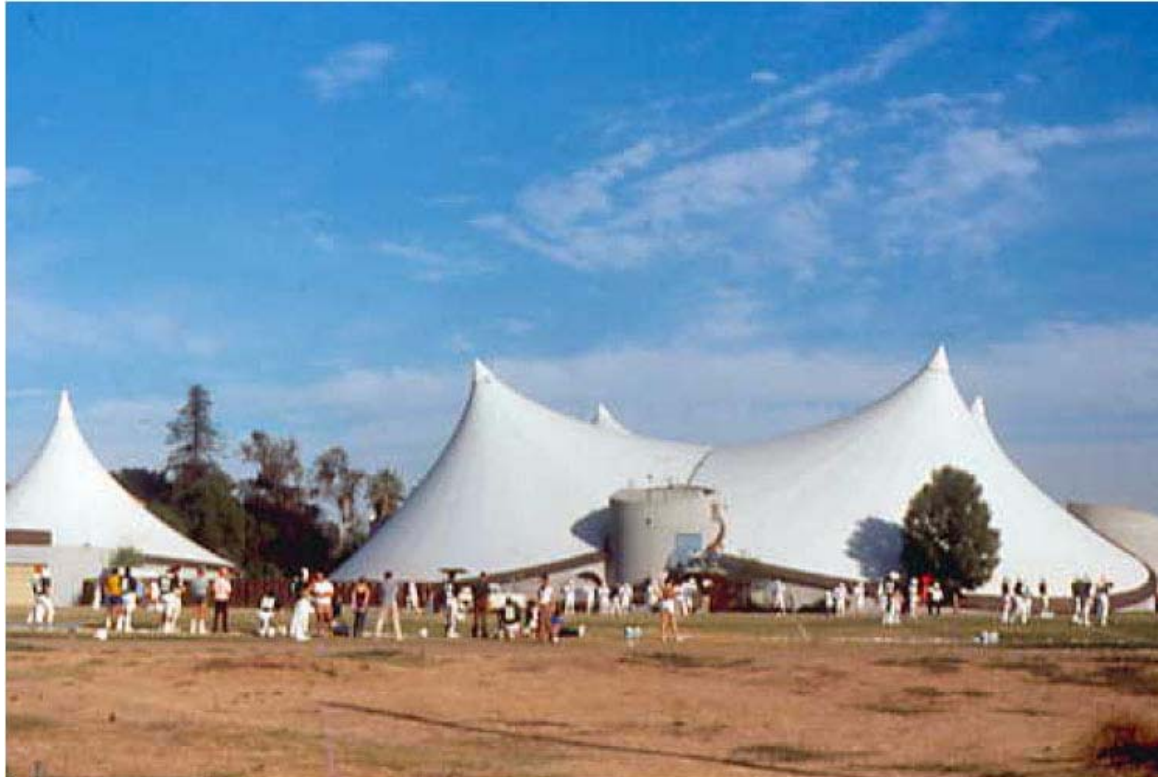
**Case Study T1**, The Sports Science and Athletic pavilion at University of La Verne, California. Erected in 1972, this was one of the first Teflon-coated fiberglass fabric structures ever built. The author reported on this structure in 1985(5) (refer figure 8), when it was still performing well. Recent advice from the owner(6) is that it is still performing well, 35 years later, and the fabric has not lost a significant amount of its original gloss. The interior liner did not last as well as the exterior fabric and has been recently replaced.

*Figure 8 – University of La Verne Sports Science and Athletic Pavilion (California)  
Erected 1972, photo taken 1985*
