Christchurch 2013 Post Earthquake Impact on Structural Design

Presented by
Stephen Hogg

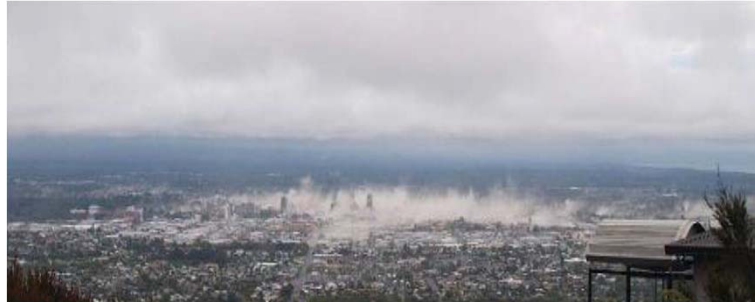
Magnitude 6.3 Earthquake strikes Christchurch CBD and is a direct hit

Peak Ground Acceleration

- 1.8g Horizontal
- 2.2g Vertical

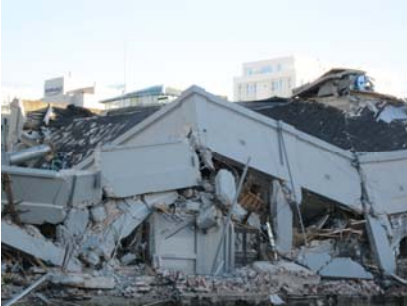
Building Damage - Earthquake February 22nd 2011 – Christchurch

- Building stock was old and heavy and not resilient to ground shaking

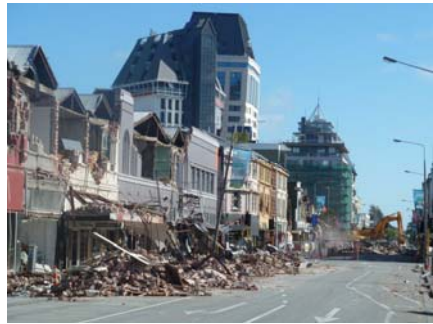
The Grand Chancellor Hotel - Big heavy and not resilient

- 1980s reinforced concrete 27 storey ductile frame building – modern capacity design damaged beyond repair

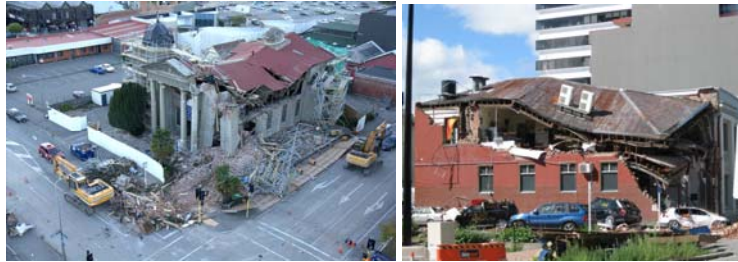
Heavy Unreinforced Masonry

- Pre 1935 buildings don't have much chance

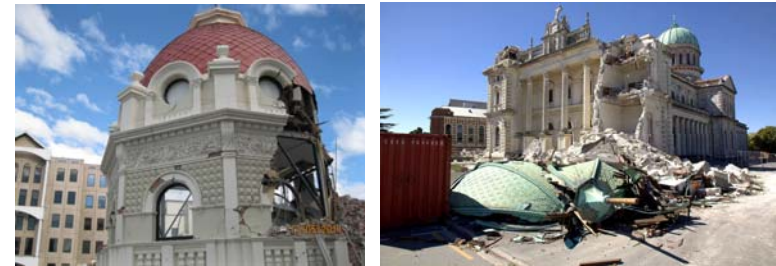
Heavy Heritage

- Many strengthened heritage buildings also damaged beyond repair

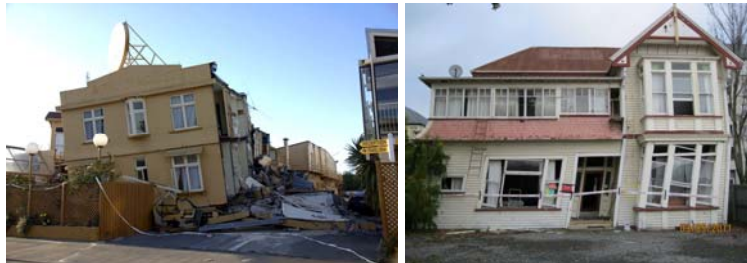
Soft storey collapse and permanent deformation

Many timber frames buildings are also destroyed from earthquake shaking

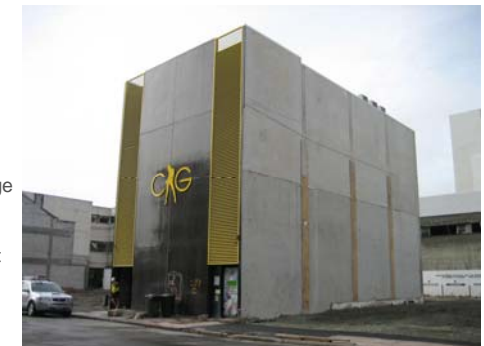
A reinforced concrete castle that survived

Key design features

- No windows
- Two doors
- Its only missing a drawbridge and a moat

This is a survivor not a resilient building

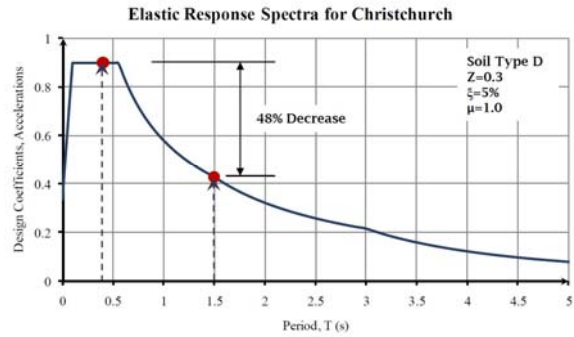
How Does It Work - A 4 Year Engineering Degree In 4 Minutes

This is how much force a building feels in an earthquake

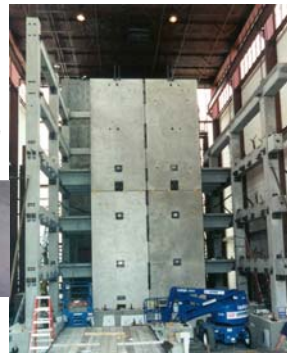
Concrete – Post Tensioned Rocking Walls

- Precast shear wall post tensioned down to foundation beam
- Shear wall can rock and return to centre under seismic loads
- Ductile shear wall damage is avoided
- Energy dissipaters absorb seismic energy and are replaceable

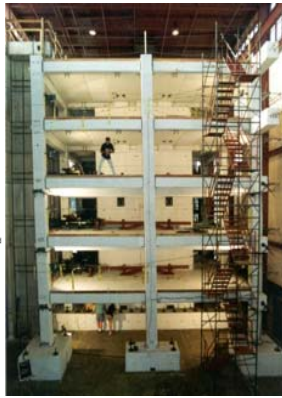
Precast Concrete or Timber – Post Tensioned Frames

- Precast concrete or Prefabricated Timber frames
- Post tensioned together to avoid damage at beam/column joints
- Frames return to centre
- Ductile frame damage to beams and columns is avoided

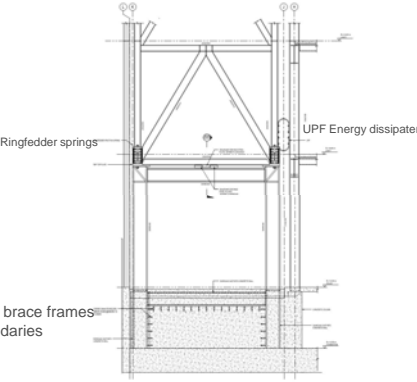
141 Cambridge Tce - Christchurch 2013

- Low damage rocking K Brace frames
- Ringfeder restoring springs at base of K brace frames
- Elastic Precast shear wall along the boundaries

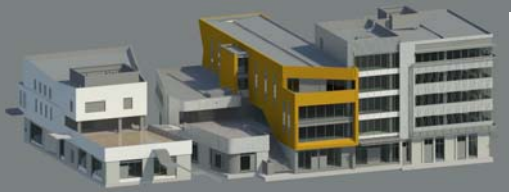
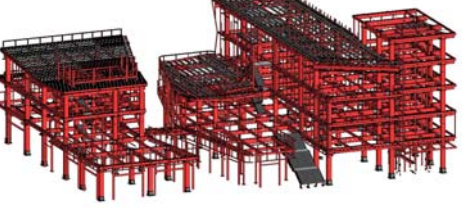
The Terrace Redevelopment – Christchurch 2013

- Low Damage - Structural Steel Two Way Sliding Hinge Joint Frame
- Sliding Hinge Joints each way using 600 x 600 steel SHS columns

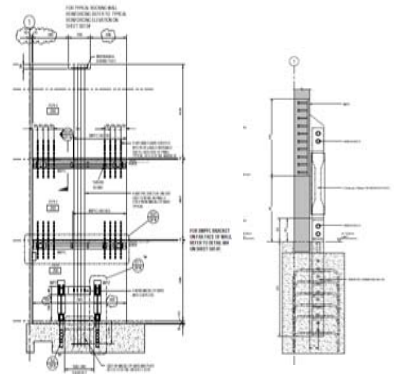
Halifax St - Nelson 2013

- Seismic bracing walls allowed to rock
- Plug and play energy dissipaters are replaceable post earthquake – tension compression yielding device
- Walls are post tensioned to provide stability and restoring

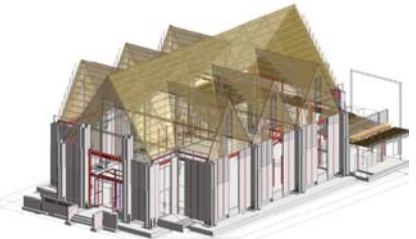
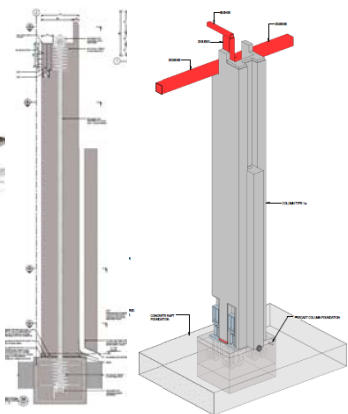
Knox Church - Christchurch 2013

- Seismic bracing piers allowed to rock
- Plug and play energy dissipaters are replaceable post earthquake – tension compression yielding device
