An Air Supported Swimming Pool Cover

Massey Park Olympic Pool Complex

Papakura

Warren Bird, Senior Engineer, Papakura District Council

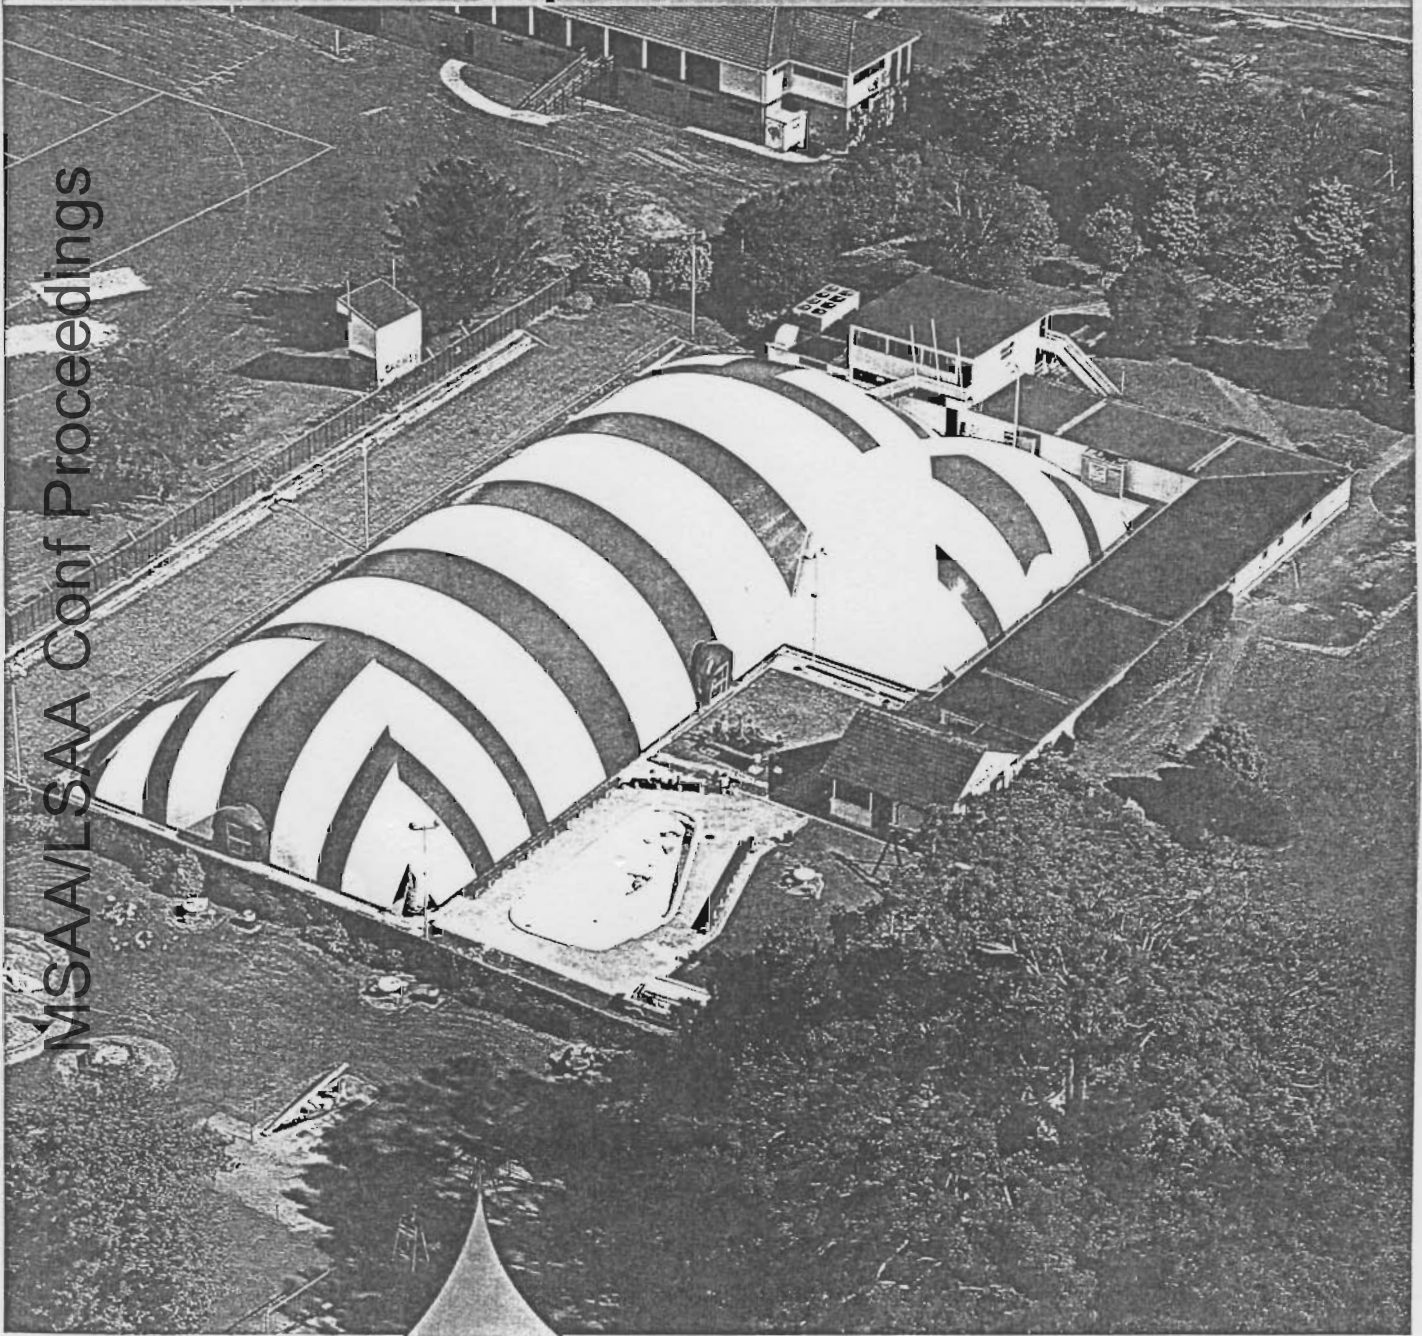
MASSEY PARK AIR SUPPORTED POOL DOME

Papakura, New Zealand
Completion Date: March 1988

The arrangement finally adopted was for an 'L' shaped dome covering the main 50m pool and also the 12m learners pool by means of a 'blister' at one end. The total floor area is 1,692m², and the total air volume enclosed by the dome which stands 9.6m high is approximately 10,600m³. The 8.0m high side hall covering the learners pool is joined to one corner of the main dome. A steel cable arcs 6.7m high to form the junction of the two halls.
